**URGENT MEDICAL DEVICE – Correction**

**Reference Number: 8010762-09/06/2023-002-C**

**CARDIOHELP-i Heart Lung Support System**

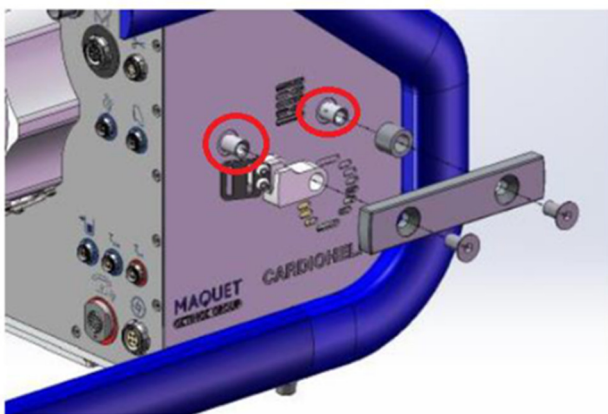
Figure 1: CARDIOHELP slide rail- exploded view

The slide rails are located on the lateral aspects of the CARDIOHELP system. They are attached to the housing of the CARDIOHELP system with the slide rail holder (see red marks in Figure 1). As shown in Figure 2, the slide rail holder consists of a nut bolt welded onto a plate.

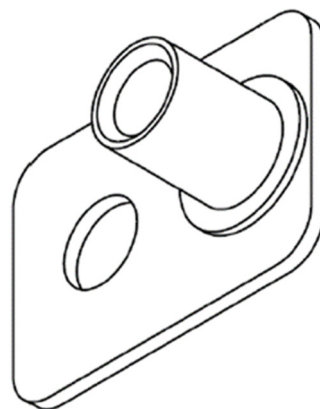
Figure 2: Draft of slide rail holder

The fixation (weld) applied by the supplier to fixate the nut bolt to the slide rail plate was insufficient. The deficient weld allows the nut bolt to break off from the slide rail plate with slight manual force.

A Getinge representative will contact you to arrange for the repair of your CARDIOHELP -i unit(s). Getinge will correct your CARDIOHELP -i unit(s) upon receipt and will return your unit(s) once correction has been completed.
