**URGENT MEDICAL DEVICE CORRECTION  
FSCA 2249723-05/05/2023-008-C**

**Datascope Cardiosave Hybrid and Rescue Intra-Aortic Balloon Pumps (IABP)**

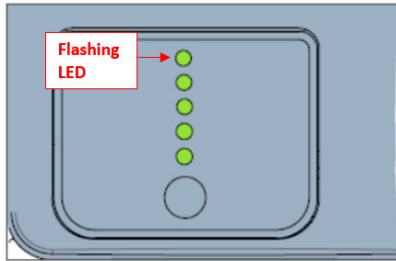
Figure 1: Battery is 80% - 100% Charging

Do NOT remove battery

To prevent electrical surges that may impair the Cardiosave's ability to charge batteries, **do not remove the battery** from a Cardiosave **when the battery level is at 80% or higher and actively charging** (i.e. successfully connected to AC power). Keep the battery in the charging bay until fully charged.

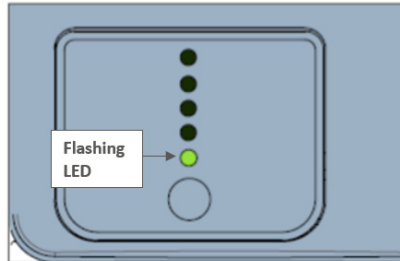
Figure 2: Battery 0%-20% Charging

Safe to remove battery

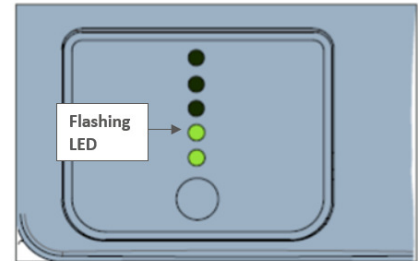
Figure 3: Battery 20%-40% Charging

Safe to remove battery

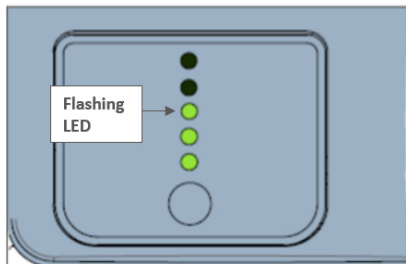
Figure 4: Battery 40%-60% Charging

Safe to remove battery

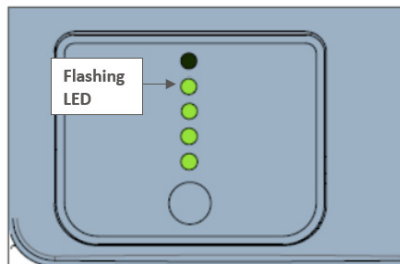
Figure 5: Battery 60%-80% Charged

Safe to remove battery

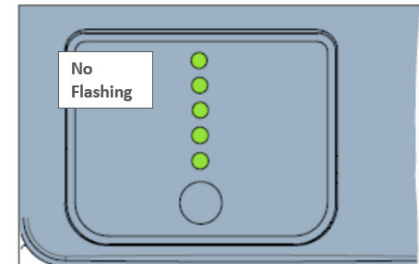
Figure 6: Fully Charged Battery

Safe to remove battery
