February 7, 2023

URGENT MEDICAL DEVICE CORRECTION

Datascope Cardiosave Hybrid and Rescue Intra-Aortic Balloon Pumps (IABP)

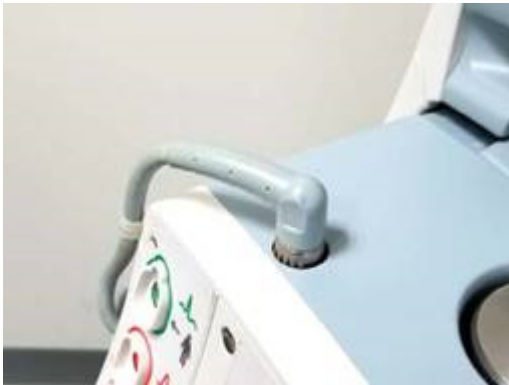
Old Pump Console Coiled Cord Connection:

An internal investigation of the complaints determined an unexpected shutdown may be due to damaged Coiled Cable Cords [part numbers 0012-00-1801 and 0012-00-1796] that provide bidirectional communication between the display head and base unit. Please refer to images below for reference.

Figure 1: Representative picture of both the old and new Coiled Cable cord design.

1. Prior to use of the Cardiosave IABP, inspect the coiled cable cord to ensure that there is no visible damage.

Datascope/Getinge has developed a hardware correction to address this issue. It is important to note that this issue is limited to units distributed prior to July 24, 2017. A Datascope/Getinge service representative will contact you to schedule the installation of the correction if your unit is affected as the correction kit becomes available. This work will be done at no cost to your facility.

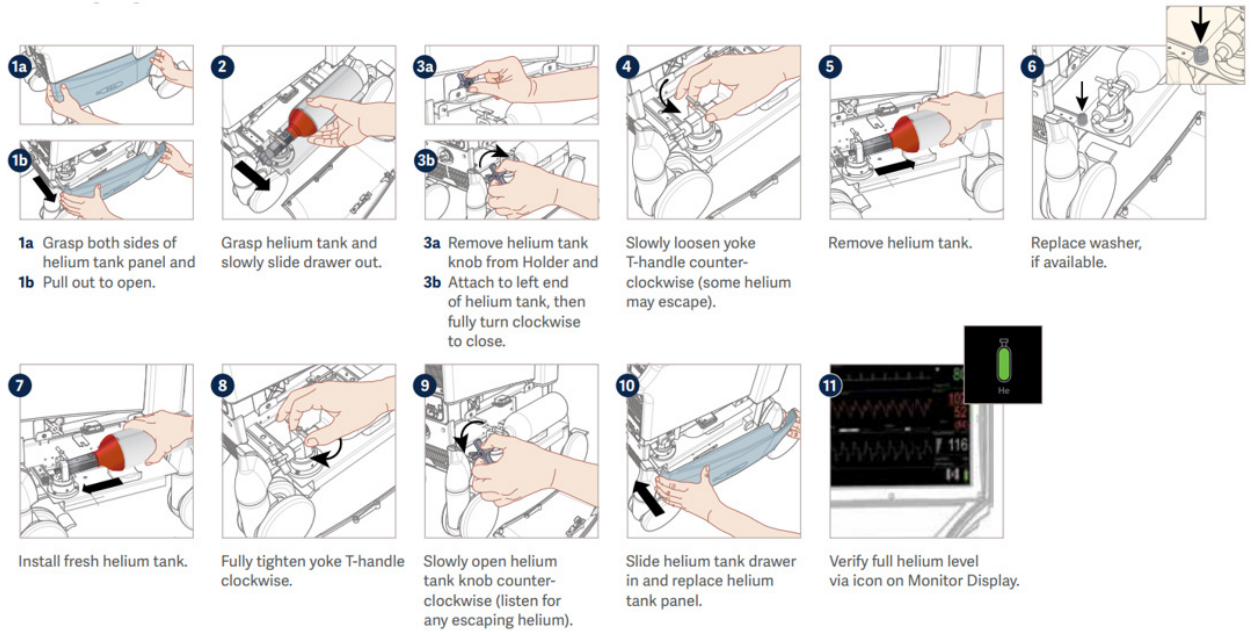
Figure 2: As pictured in **Cardiosave Hybrid and/or Rescue Operating Instructions**

There have been reported failures of the high pressure helium regulator which may cause a helium leak in the Cardiosave Hospital Cart. The high pressure helium regulator is located in the Cardiosave Hospital Cart and regulates the helium pressure of the external helium supply. In instance of helium regulator failure, a Pump Console's internal reservoir of helium will not be replenished when docked into an impacted Hospital Cart. This may result in an insufficient amount of helium within the internal reservoir. Please refer to images below for reference.

1. During Installation and Replacement of the Helium Tank per the Cardiosave Operating Instructions, please ensure care is taken not to damage the helium tank or the helium tank yoke while inserting and/or removing the helium tank.
2. Please follow the instructions for use when changing the helium tank.

3. If user observes any visual damage on High Pressure Regulator, please contact your Datascope/Getinge service representative.

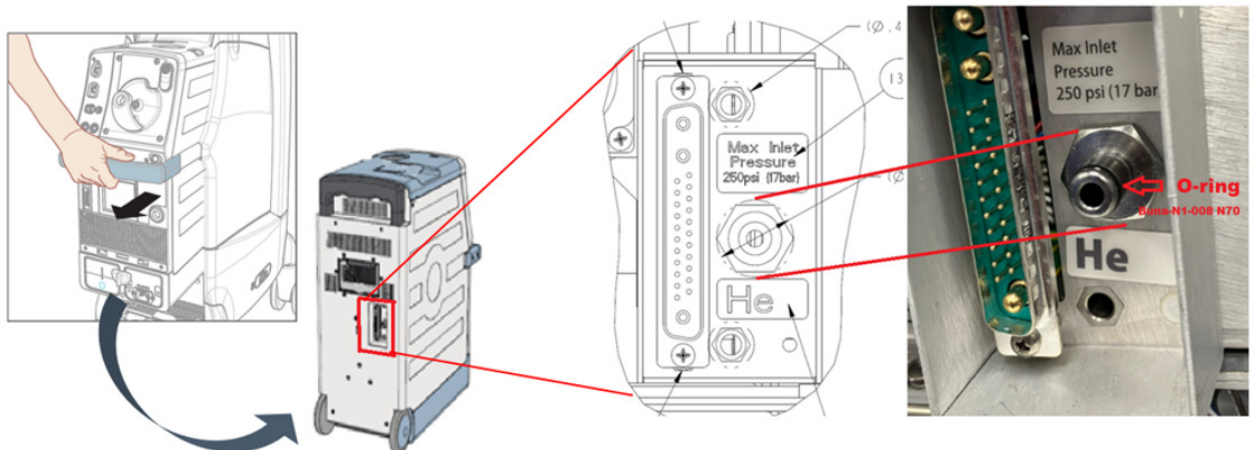
There have been reports of damaged, worn, or torn O-rings on the Cardiosave Pump Console quick disconnect fitting resulting in helium tank leaks. The quick disconnect fitting is the point of connection that permits the refilling of the Pump Console's internal helium reservoir when the Pump Console is docked in the Hospital Cart. Please refer to images below for reference.

Figure 3: Drawings as pictured in **Cardiosave Hybrid and/or Rescue Operating Instructions**, along with a final picture of the O-ring as it appears on the unit.

1. If user observes any visual damage to the O-ring installed as part of the quick disconnect fitting, please contact your Datascope/Getinge service representative. If possible, remove the IABP from patient use until appropriate repairs can be made.

Datascope/Getinge is currently updating the annual Preventive Maintenance instruction to include replacement of the quick disconnect fitting O-ring.
