July 31, 2023

**URGENT MEDICAL DEVICE CORRECTION**  
**FSCA 2249723-06/02/2023-009-C & FSCA 2249723-06/02/2023-012-C**  
**Datascope Cardiosave Hybrid and Rescue Intra-Aortic Balloon Pumps (IABP)**

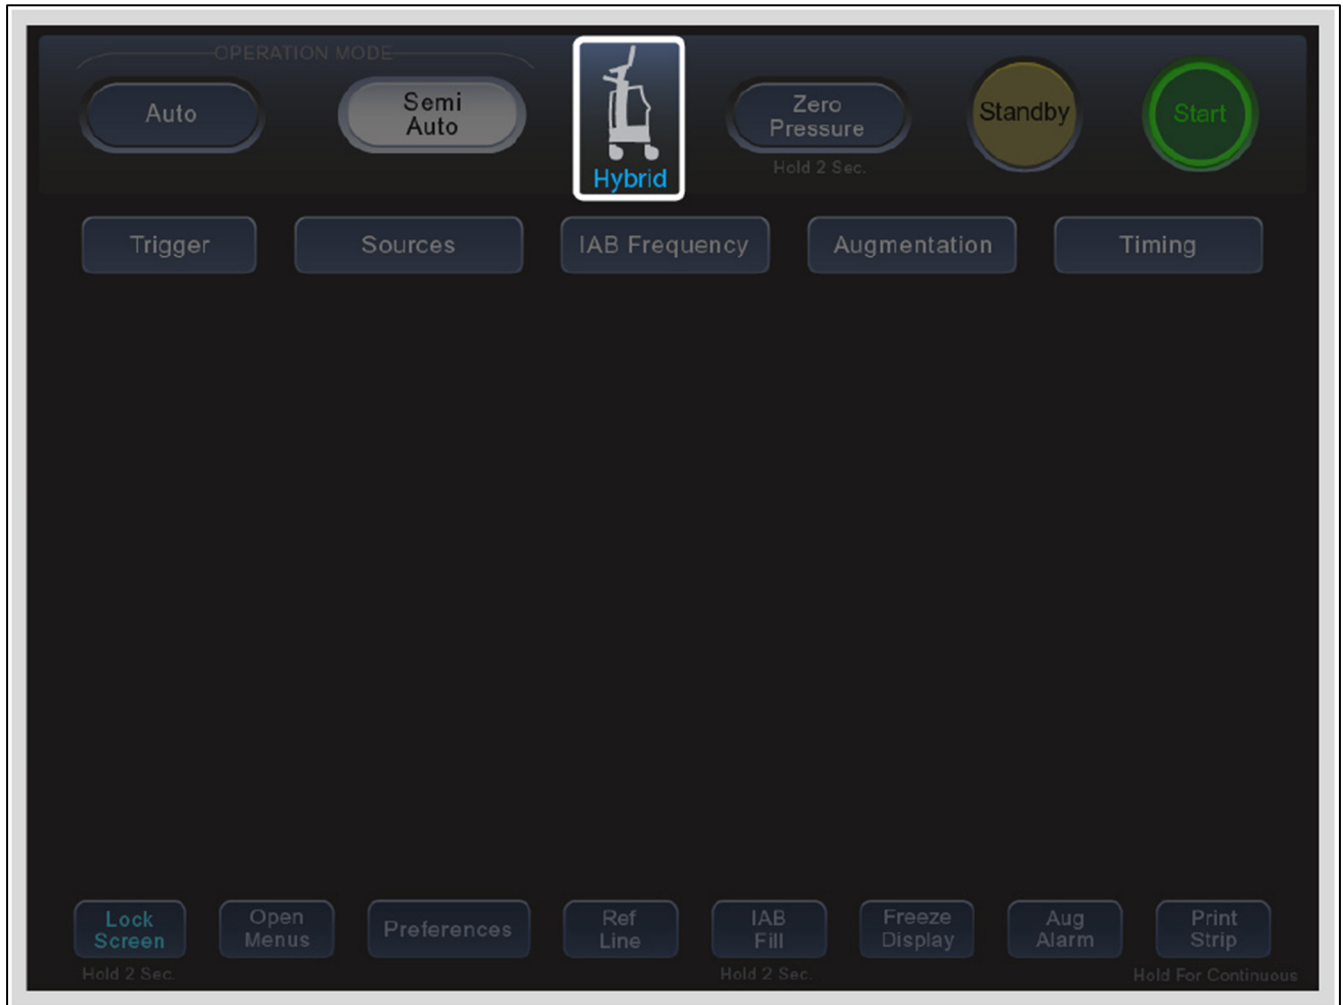
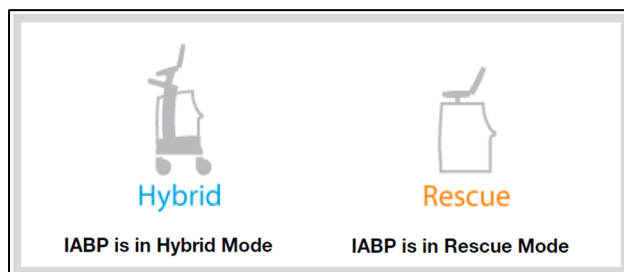
The IABP Configuration Icon shows the current mode of configuration for the IABP, Hybrid (in the hospital cart) Mode or Rescue (transport) Mode. The icon is located at the top center of the IABP display screen.

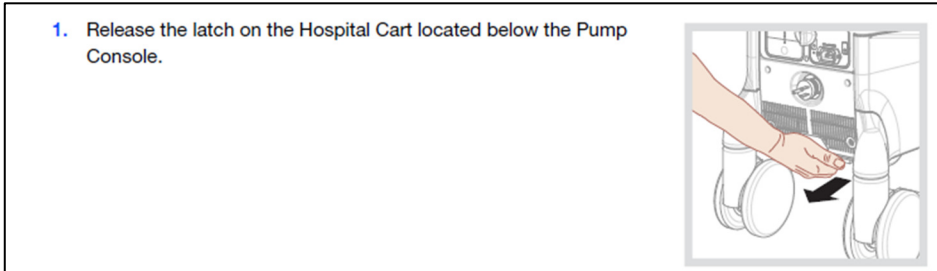
- 1) The Cardiosave Hospital Cart's release latch has been released and the IABP console is not properly installed in the cart.

In both cases, information is provided to the user that the system is not in Hybrid mode via the Rescue Mode Icon on the bottom Cardiosave screen (top center of the screen). In addition, the “battery in use” message will be displayed in the informational message area even if the AC power cord is plugged in.

Additionally, in both scenarios, the Cardiosave will not receive AC power and if the device is in operation, it will continue to operate on battery. When the Cardiosave is not receiving AC power, the batteries are unable to charge.

If the AC Plug Icon is not present and/or the Rescue Icon is present, release the latch on the Hospital Cart located below the Pump Console, then grab the handle and slowly slide out the console approximately one quarter of the way.

Grab the handle and slowly slide the Pump Console into the Hospital Cart until it locks into place. You will hear an audible click noise and three audio tones of increasing volume will sound once the console is locked into the Hospital Cart.

To ensure the Pump Console was successfully installed into the Hospital Cart, plug the Hospital Cart power cord into a compatible grounded AC receptacle, and confirm AC operation by checking the battery icon to confirm the pump is using AC power.

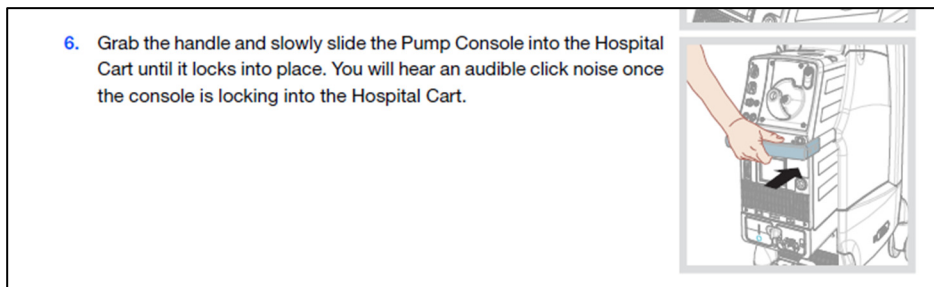
- 2) The IABP console is inserted into the hospital cart, but is not fully latched into the cart
