July 22, 2022

**URGENT MEDICAL DEVICE REMOVAL EXPANSION**  
**HLS Set Advanced**

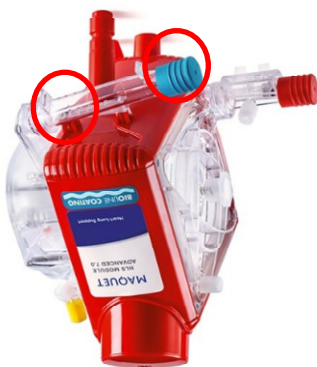
**Figure 1**

MCP/Getinge has received 15 complaints reporting damage to the Tyvek cover. The position of the perforations were consistent across the complaints and corresponded with the tabs of the venous measuring cell within the packaging on either the left or the right side (see Figure 1, Figure 2 and Figure 3). The results of the product packaging investigation suggests that the Tyvek damage only occurs if the HLS Set is dropped upside down causing either the Velcro straps holding the HLS Module to come loose or the HLS Module to detach. A shift/movement of the HLS Module enables the venous measuring cell tab(s) to perforate the Tyvek cover and the sterile barrier system may be compromised.

Figure 1: HLS Module with the venous measuring cell tabs

- Option 2:
  - If the products are necessary based on expert clinical judgement, you can use the devices after following these inspection measures:
    1. Prior to use, the HLS Sets Tyvek covers must be checked visually for any damages, holes or tears in order to prevent the use of an unsterile medical device.

2. After removing the tray from the secondary package (white cardboard box), position the tray in a well-lit area outside the sterile field.
    3. Check the integrity of the sterile barrier of the tray (Tyvek cover) before use.

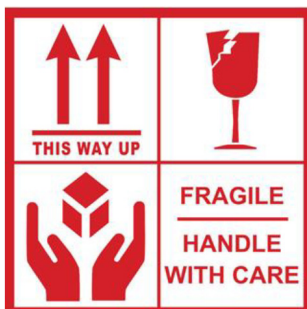
Figure 4: Example of new box label

The product you receive will be labeled on all four side panels indicating special instructions for shipment, handling and storage (see Figure 4). A more controlled shipment method will be utilized to limit the possibility of upside down drops. All HLS Sets will have an additional "Safety Notice" affixed on the white box, which will allow easier identification of the current packaging design as well as provide instruction to identify possible damage to the package prior to use.
